**DEPARTMENT OF TRANSPORTATION****DIVISION OF ENGINEERING SERVICES**

Contract #: 04-0120F4Cty: SF/ALA Rte: 80 PM: 13.2/13.9File #: 69.28**WELDING INSPECTION REPORT****Resident Engineer:**Pursell, Gary**Address:** 333 Burma Road**City:** Oakland, CA 94607**Report No:** WIR-001247**Date Inspected:** 16-Dec-2007**Project Name:** SAS Superstructure**OSM Arrival Time:** 630**Prime Contractor:** American Bridge/Fluor Enterprises, a JV**OSM Departure Time:** 1530**Contractor:** Zhenhua Port Machinery Company, Ltd (ZPMC), Changxing Island **Location:** Shanghai, China**CWI Name:** Xu Lefeng**CWI Present:** Yes No**Inspected CWI report:** Yes No N/A**Rod Oven in Use:** Yes No N/A**Electrode to specification:** Yes No N/A**Weld Procedures Followed:** Yes No N/A**Qualified Welders:** Yes No N/A**Verified Joint Fit-up:** Yes No N/A**Approved Drawings:** Yes No N/A**Approved WPS:** Yes No N/A**Delayed / Cancelled:** Yes No N/A**Bridge No:** 34-0006**Component:** Tower Mock-up**Summary of Items Observed:**

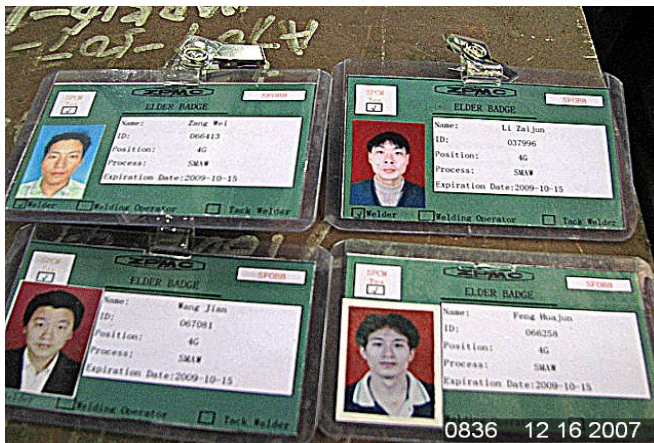
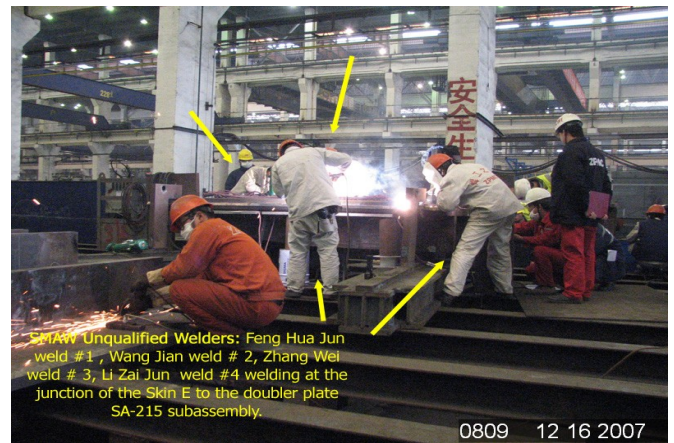
question. ZPMC stopped welding. After looking in their records ZPMC said that the welders in question were not qualified in 2G position and that ZPMC would not allow them to weld in that position. Mr. Shen informed that the production supervisors want to proceed welding and they were asking for the QA inspector opinion. The QA inspector said that he could not give an opinion about this matter at this time. The QA inspector had a phone conversation with Task Leader Robert Cuellar. The QA inspector brought to the attention of Mr. Cuellar that ZPMC was using unqualified welders to weld the Skin E to the doubler plate. The welders used were approved to weld 4G and 1G position only. Mr. Cuellar said that an incident report needed to be issued to address this matter. The photographs below show the unqualified welders.

Note: The QA Inspector reviewed the revision # 7 for the approved ZPMC welder and welding operators qualification list and the QA Inspector found the above welders only qualified on SMAW on the 4G position.

SMAW Unqualified Welders: Feng Hua Jun weld #1, Wang Jian weld #2, Zhang Wei weld #3, Li Zai Jun weld #4 welding at the junction of the Skin E to the doubler plate SA-215 subassembly.

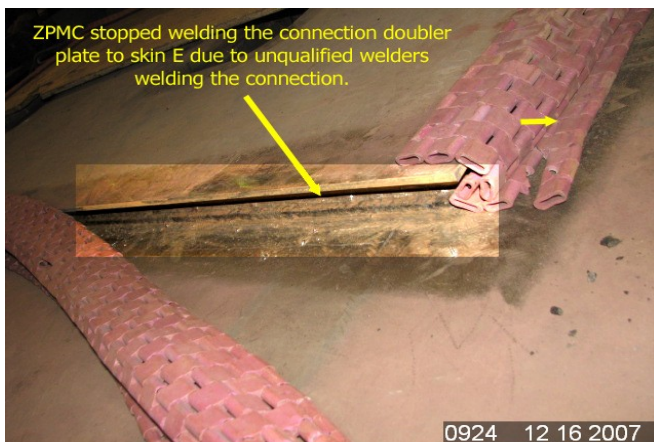
ZPMC stopped welding the connection doubler plate to skin E due to unqualified welders welding the connection.
